Soldiers & Sailors Monument Reconstruction

Project M071-323M

Landmarks Preservation Commission Review June 11, 2024

WXY architecture + urban design NYC Parks

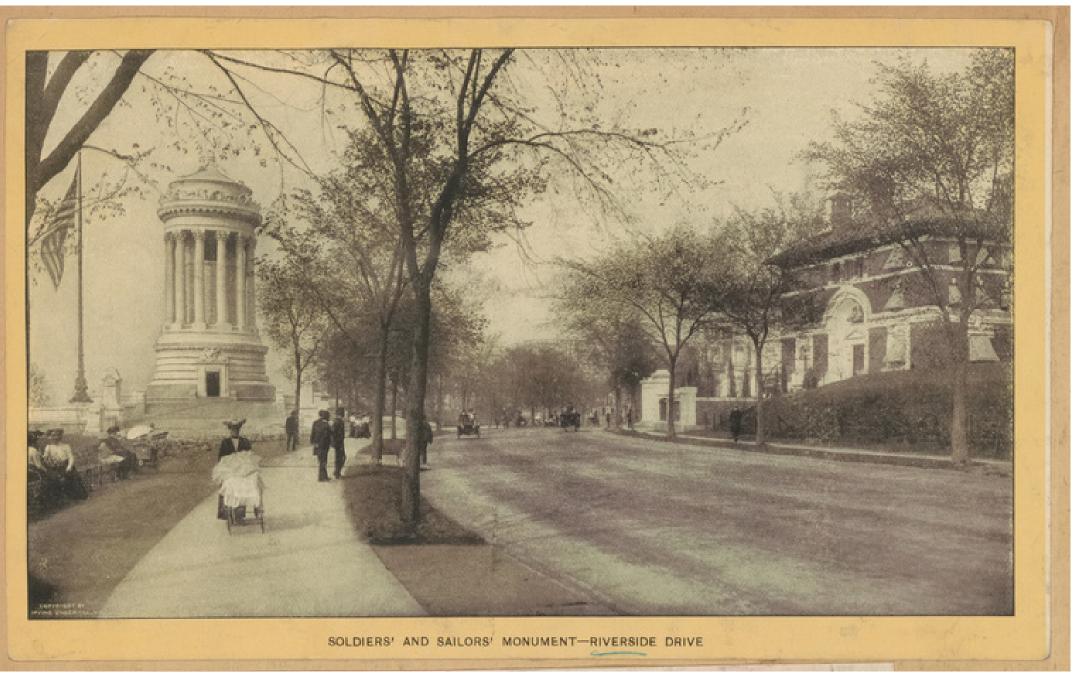
1— Approaching the Monument from the South along Riverside Drive, c. 1935

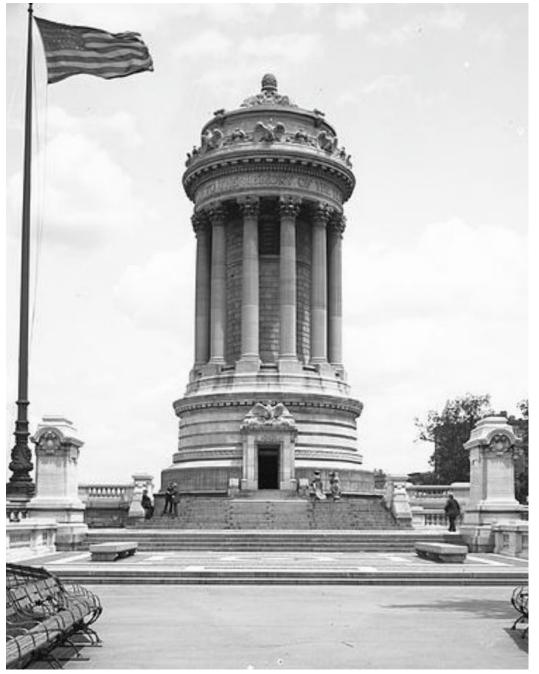
1— View from he South Plaza, 1911

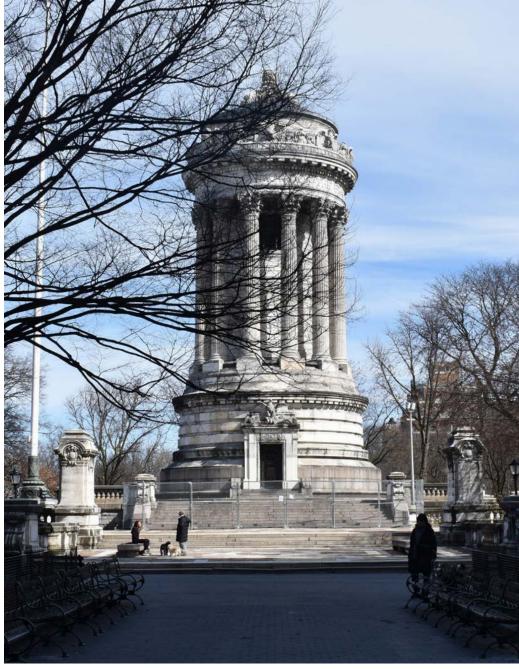
2— View from South Plaza, 2024

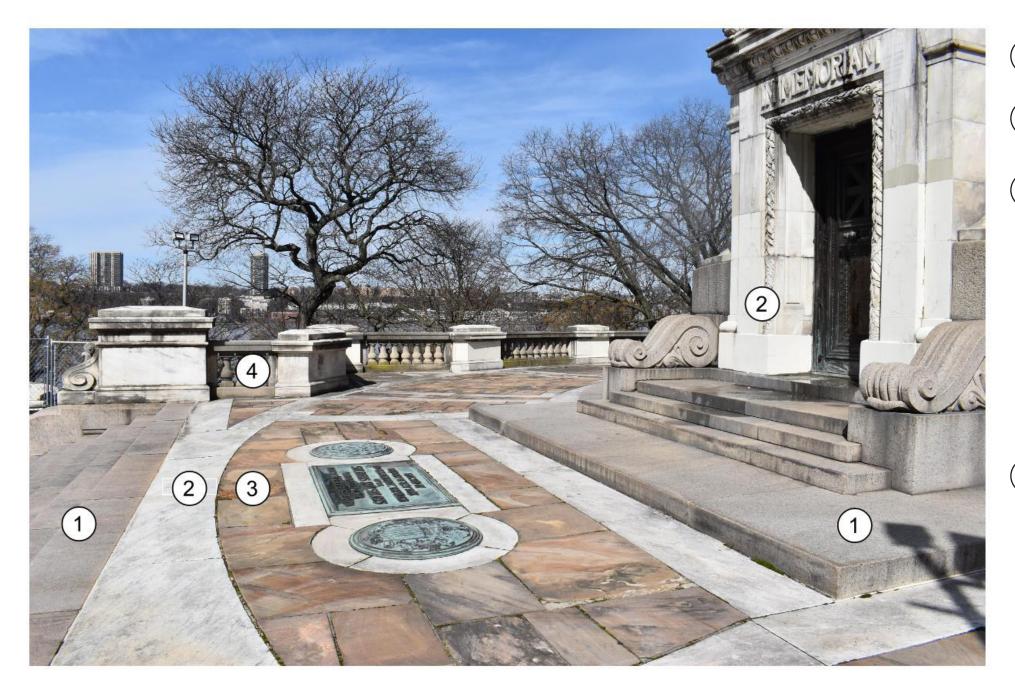
Soldiers & Sailors Monument Reconstruction Riverside Park | **Restoration Palette**

(2) The existing marble, c. 1902, is to be restored.

The existing crab orchard sandstone, c. 1962, is (3) proposed to be replaced with custom brick pavers as per the original Stoughton & Stoughton design intent

The existing limestone balustrade, (4) c. 1962, is to be restored

The existing grey granite, c. 1902, is to be restored.

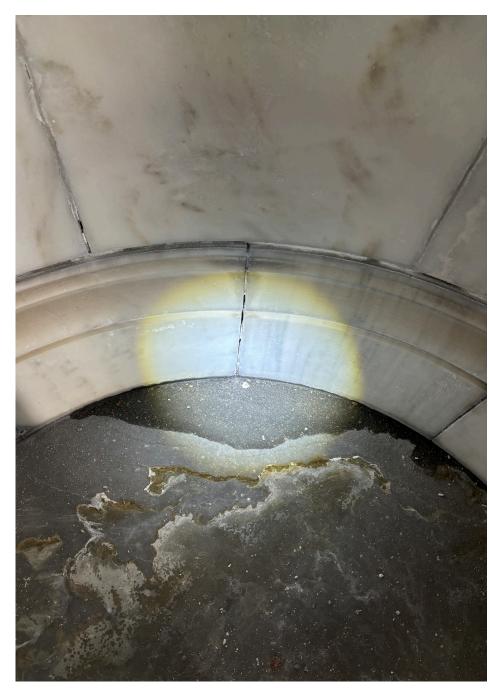
2— Evidence of water intrusion & damage

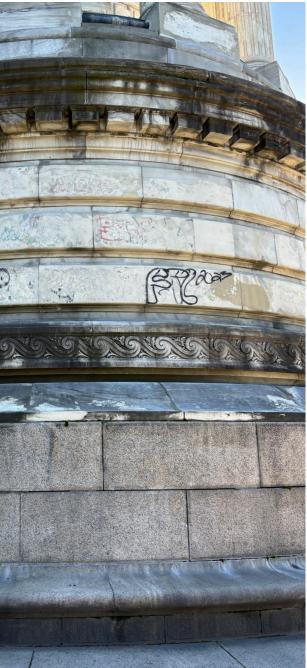
3— Deterioration of masonry elements

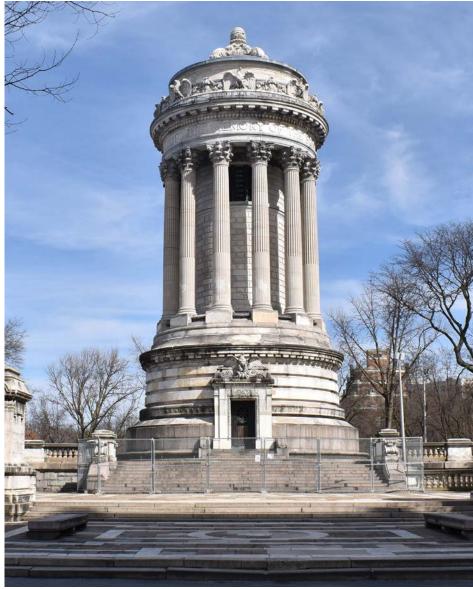
Tower Exterior Repair

- Remediate deteriorated mortar & masonry joints
- Repair & replace roofing and flashing
- Repair & restore corroded metal elements

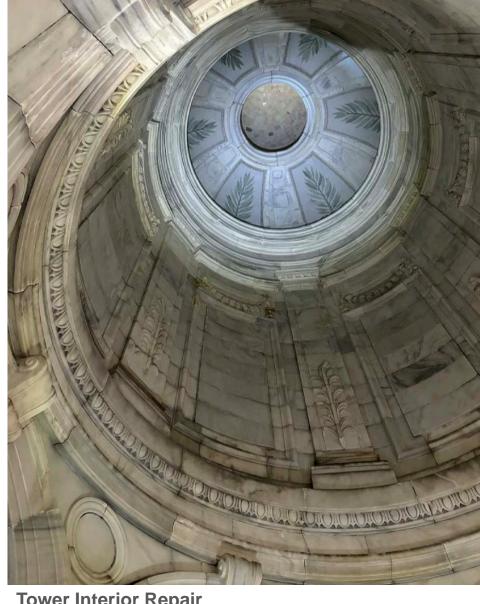
- **Tower Interior Repair**

- Remediate deteriorated mortar & masonry joints - Repair and restore mosaic tile floor - Repair & restore corroded metal elements

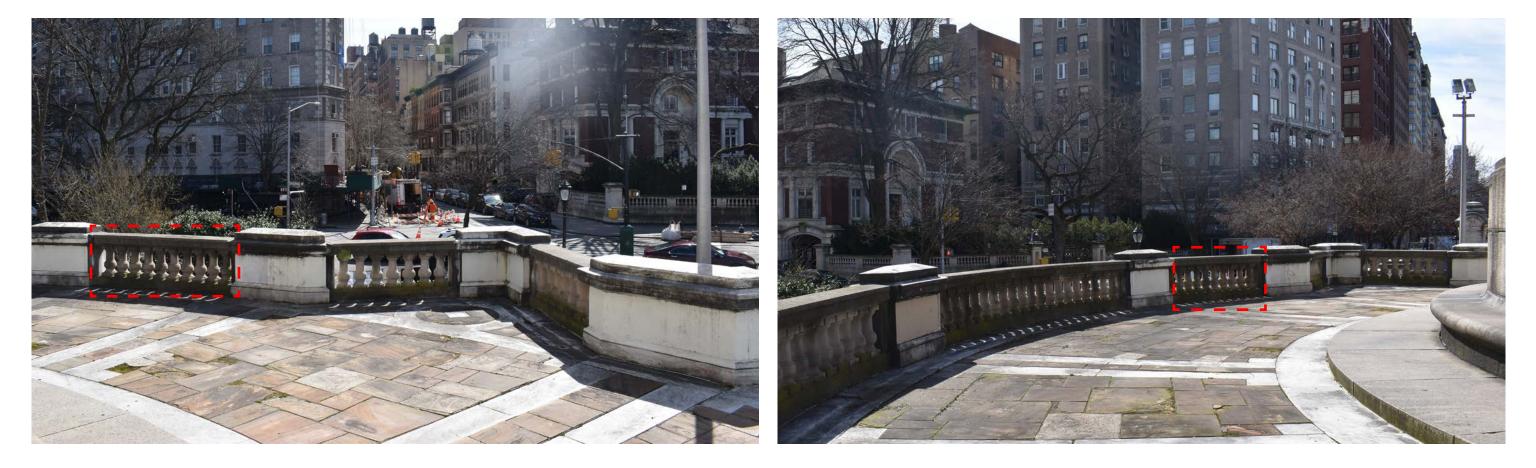
Soldiers & Sailors Monument Reconstruction Riverside Park | Garden Walkway: Balustrade Impact at Upper Terrace

MISSING
 DUTCHMAN
 NOT
 INCLUDED
 [ST (MA) 05] SF: 1]

EXISTING
 DUTCHMAN
 NOT
 INCLUDED
 [ST (MA) 05] SF: 1]
286 282 287 288 ST (MA) 03 SF: 3 ST (MA) 03 SF: 2 282 283 MISSING DUTCHMAN ST (MA) 02 SF: 1 287 289 291 FAILING PATCH (ST (LI) 01 LF: ST (MA) 03 SF: 2 287 289 (ST (MA) 03 SF: 1 MISSING CORNER 278 279 ST (MA) 05 SF: 3 EXISTING DUTCHMAN 279 (ST (MA) 05 SF: 2 EXISTING DUTCHMAN INSIDE FACE 280 (ST (MA) 03 SF MISSING DUTCHMAN OUTSIDE FACE ST (MA) 05 SF: 1 287 292 ST (MA) 05 SF: EXISTING DUTCHMAN OUTSIDE FACE ST (MA) 02 SF: 1 287 289 293 294 282 295 296 (ST (LI) 01 | LF: 4 1) LOWER AND UPPER TERRACE - EAST ELEVATION

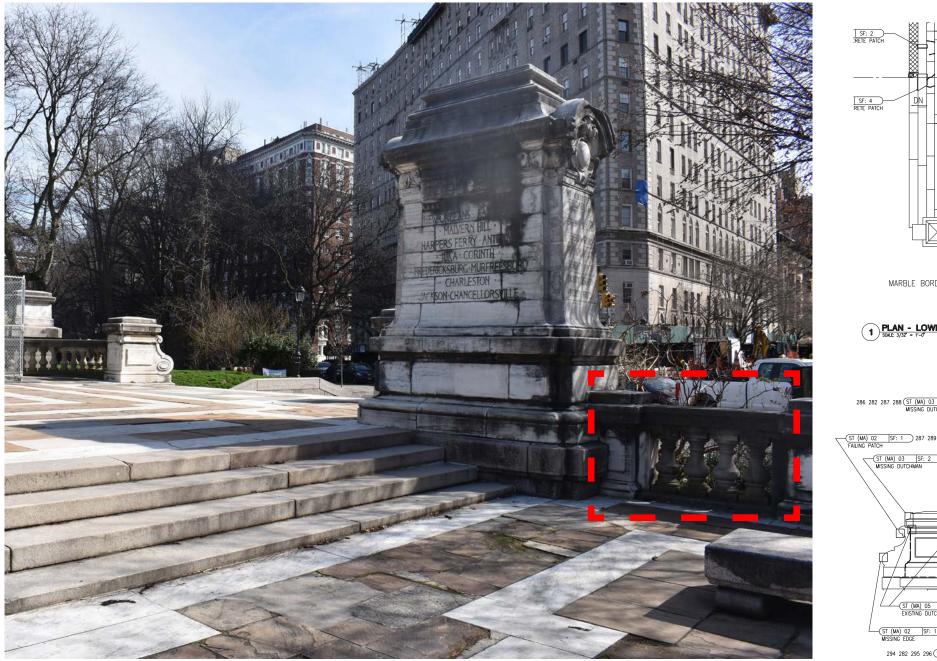
Soldiers & Sailors Monument Reconstruction Riverside Park | Garden Walkway: Balustrade Impact at Lower Terrace

1962 Balustrade components to be removed and salvaged for use where needed in monument restoration

7 36 (ST (GR) 04 EA: 1 DISPLACED STONE STE 5 ST (MA) 04 EA: 2 DISPLACED STONE WITH CONCRETE LEVELER MARBLE BORDER, TYP. 34 (ST (MA) 04 | EA: 1 3 (PO 01 WIDE OPEN JOIN -(ST (MA) 05 S EXISTING DUTCHMA INSIDE FACE SE- 1 282 28
 INSIDE
 FACL

(ST (MA) 03
 [SF: 1]
 281 284

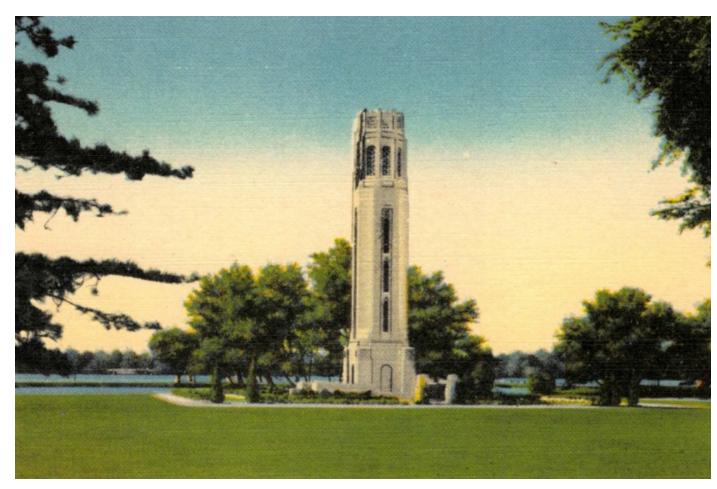
Before

Upon the site's opening in 1939, the Nancy Brown Peace Carillon on Belle Isle, Detroit, MI was predominantly surrounded by open lawn.

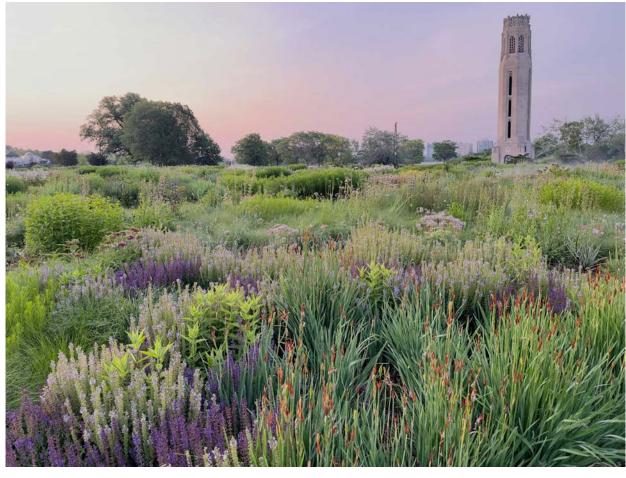
After

In 2021, an ecological 3 acre garden consisting of perennials, grasses, shrubs, and trees was added in front of and around the Nancy Brown Peace Carillon. Plants were selected based on their hardiness, durability, and ever-changing textures and colors for enjoyment in all four seasons.
